Site Observation on Fault Geometry and Coseismic Behavior of Nay Pyi Taw Segment, Sagaing Fault

Dr.Sandy Chit Ko
Professor
Department of Geology,
Maubin University

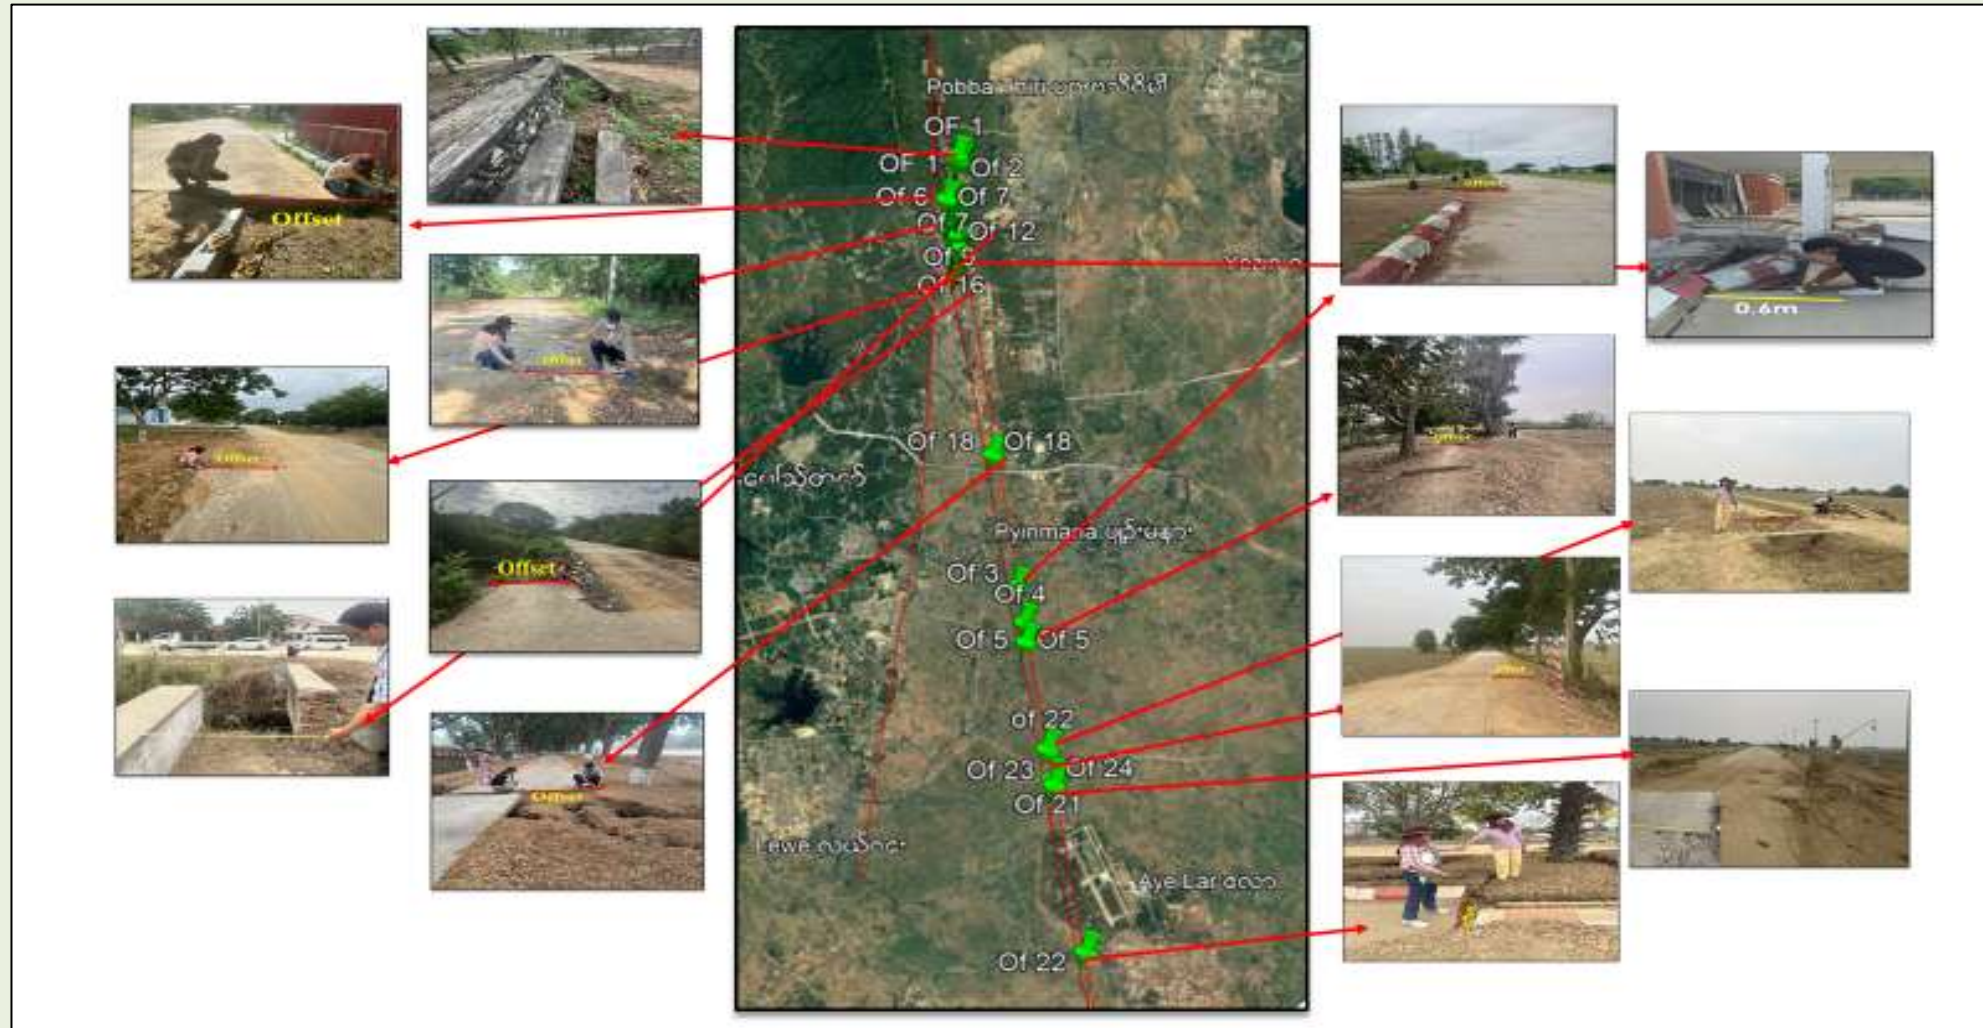
Some Offset features along the surface ruptures

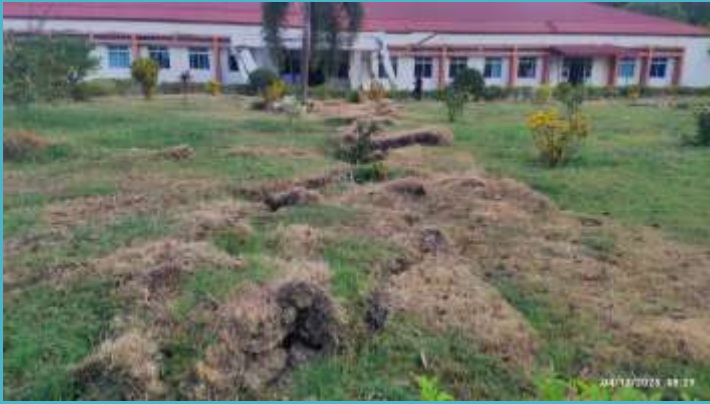
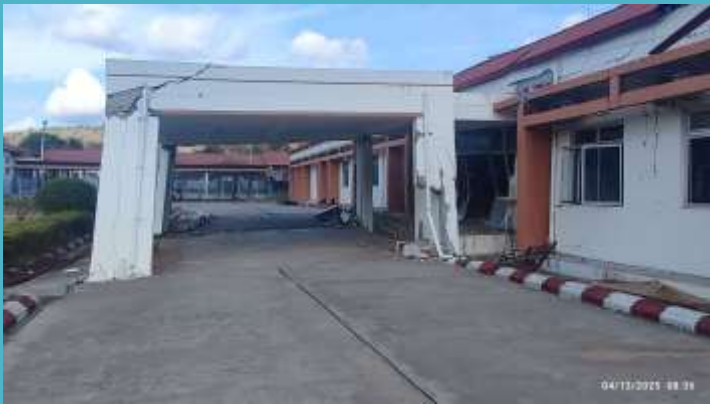
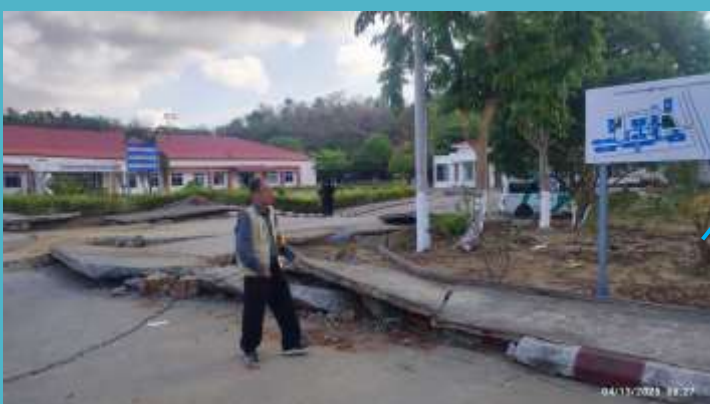
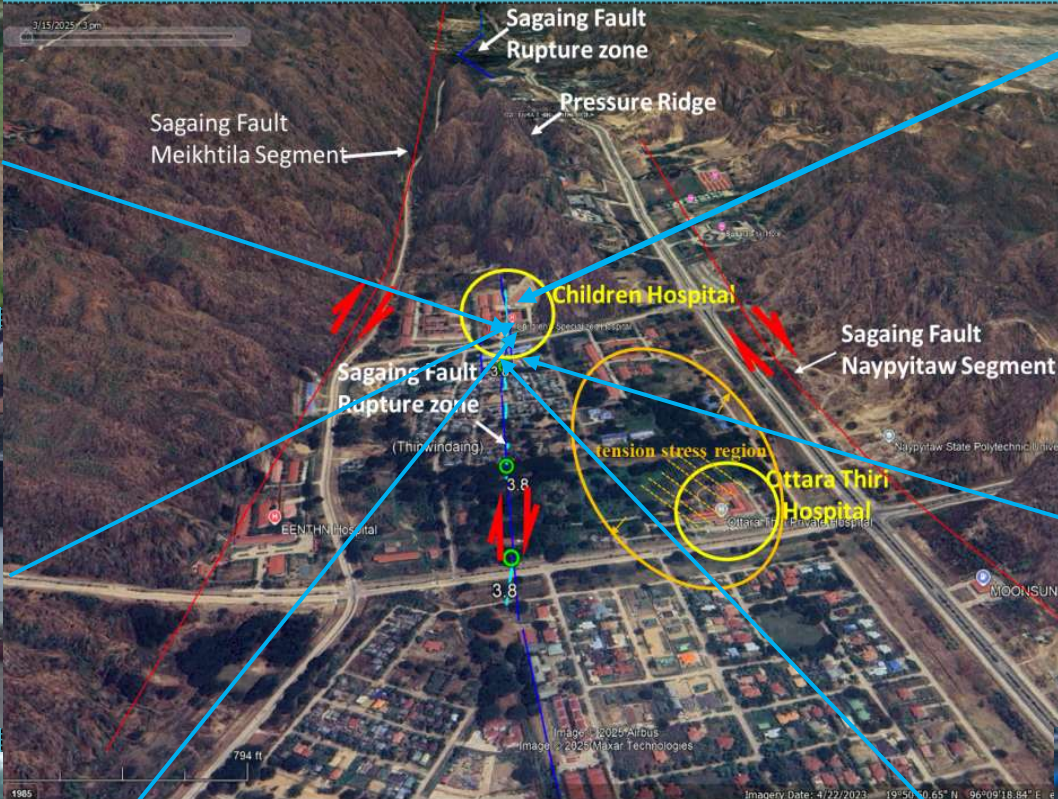
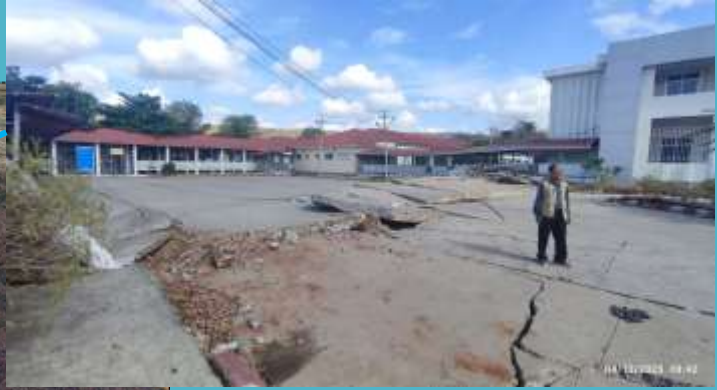
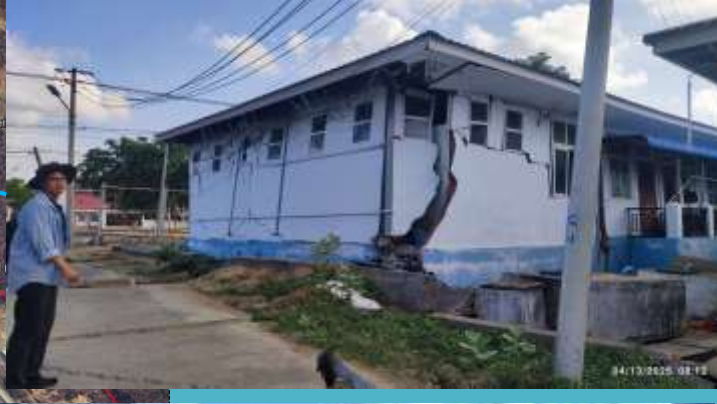
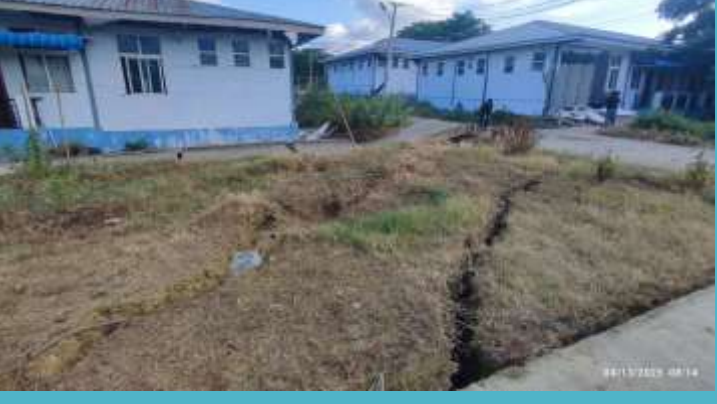
ဥတ္တရသီရိ ကလေးဆေးရုံ ထိခိုက်မှုအနေအထားအချို့

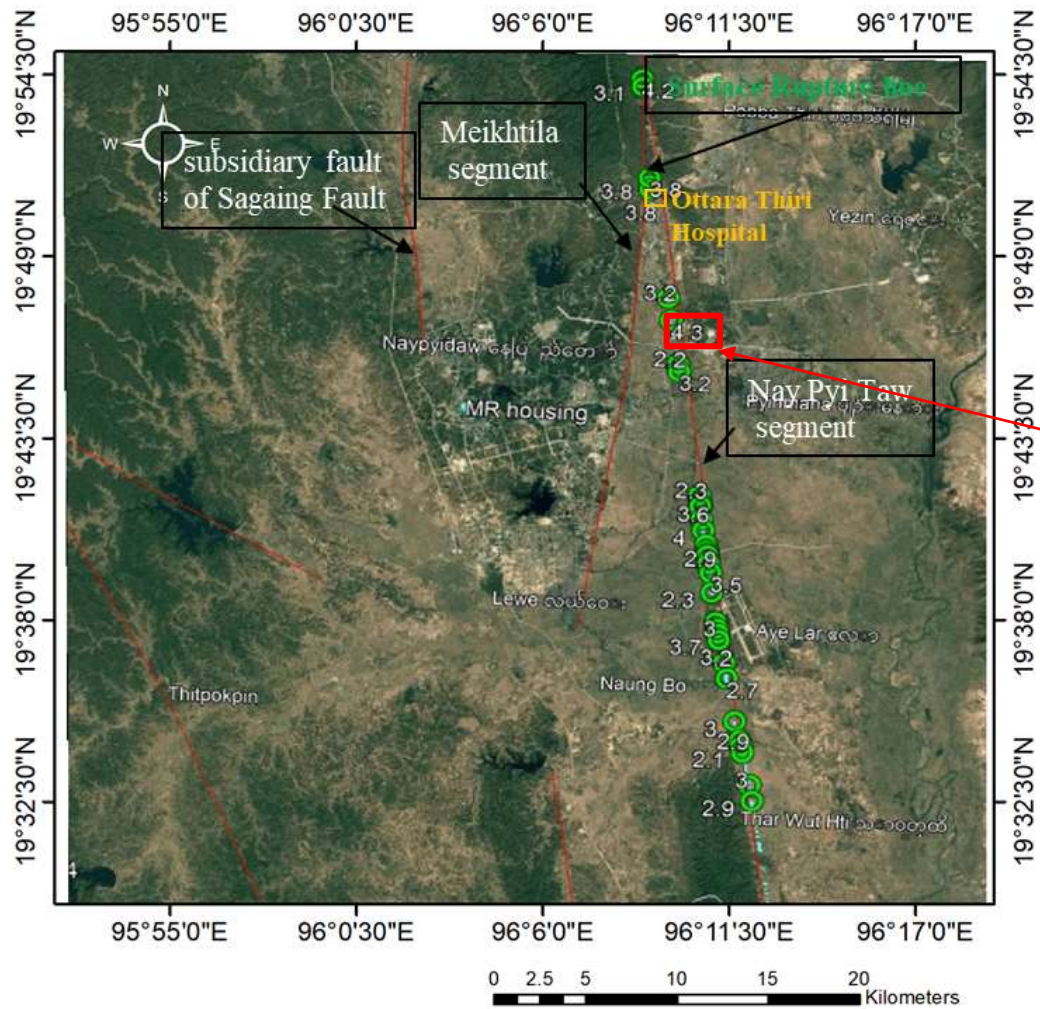
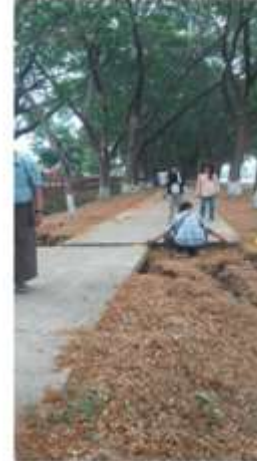
လက်လုပ်တောင်
ချစ်သူလမ်းကြား

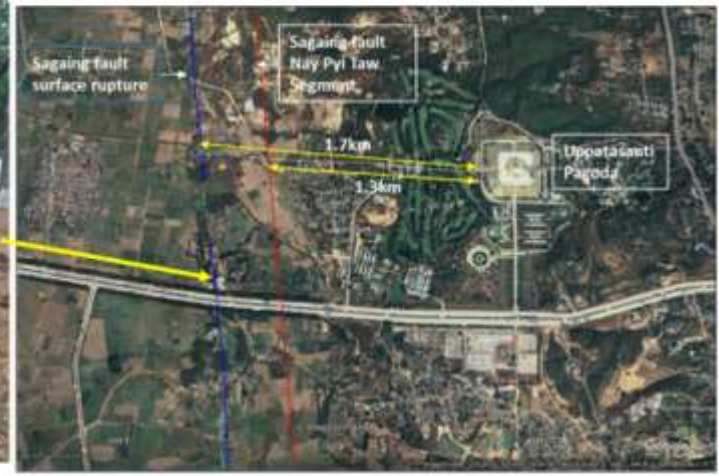
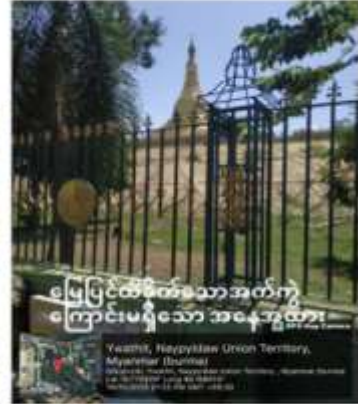
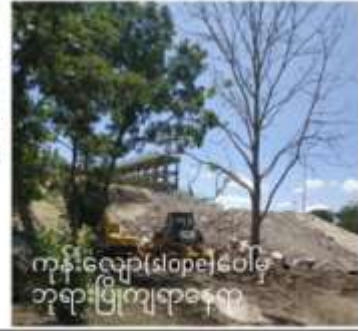
ကုန်းလျော့(slope)ငေါ့
ဘုရားပြိုကျရာနေရာ

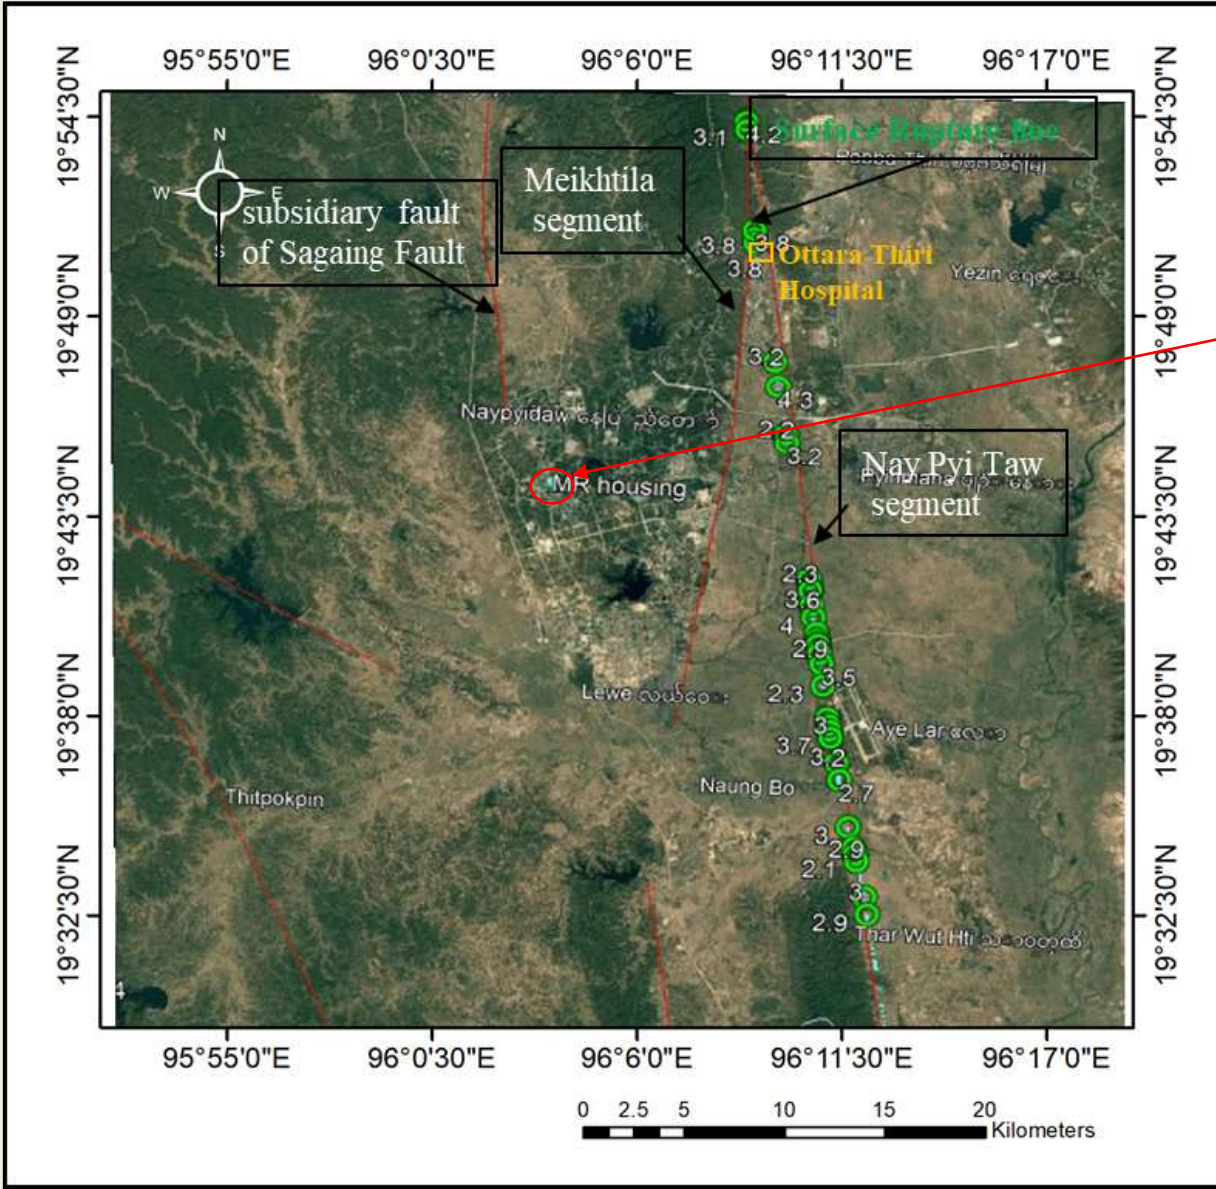
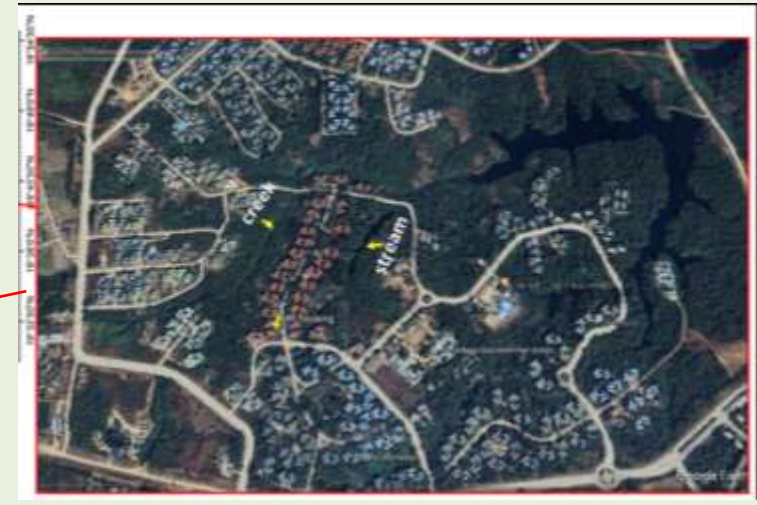
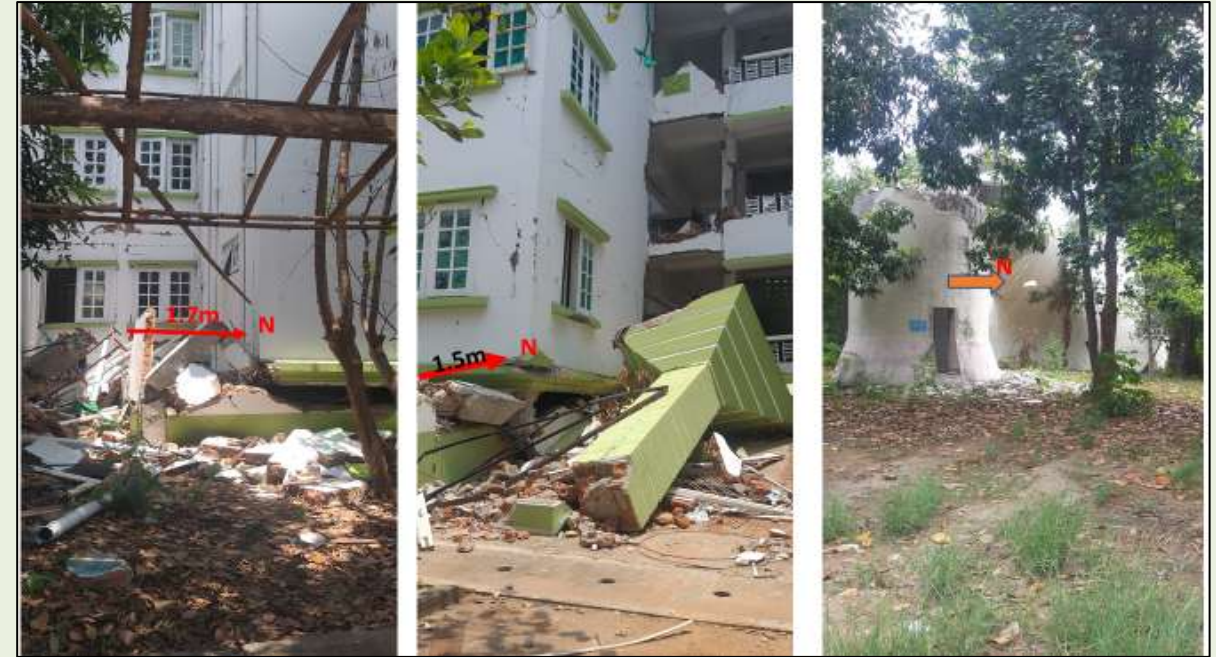
ခရေအိမ်ရာ ထိခိုက်ပျက်စီးမှု အချို့ပျက်စီးမှု အနေအထားပြပုံ

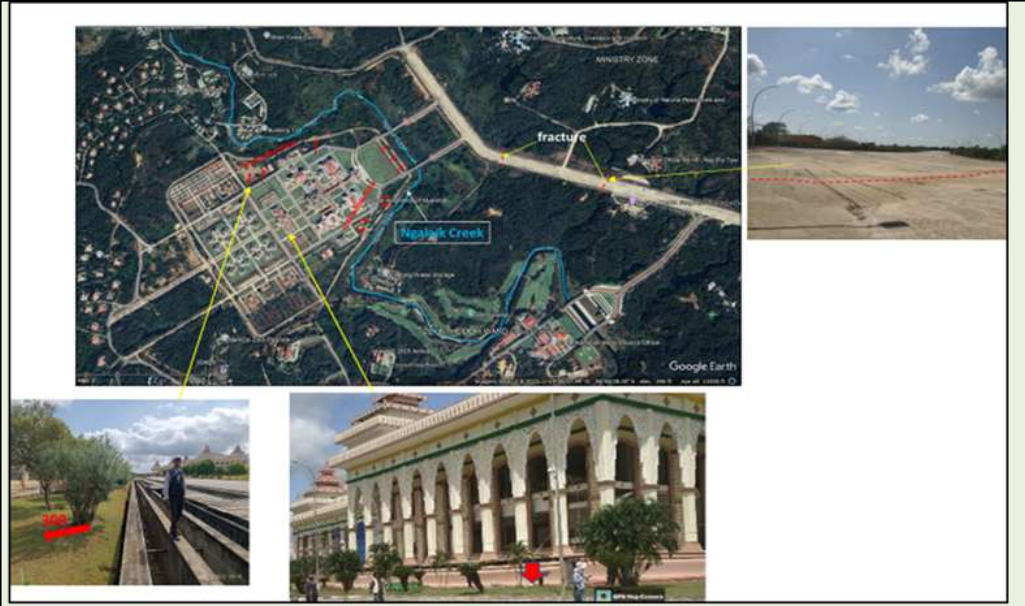
Damages at the Northwest part

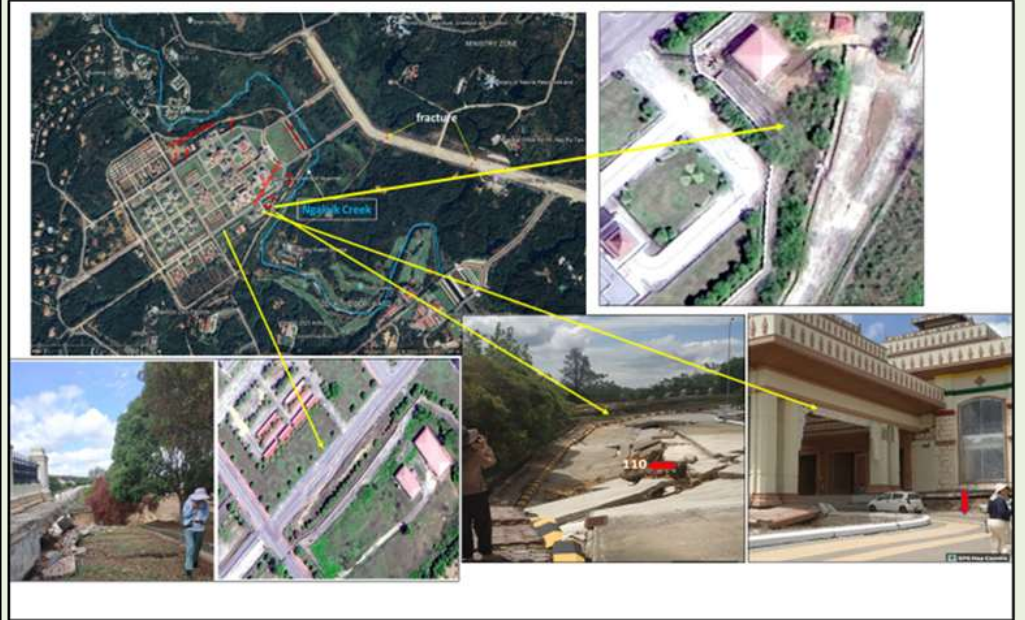
Damages at the Northeast part

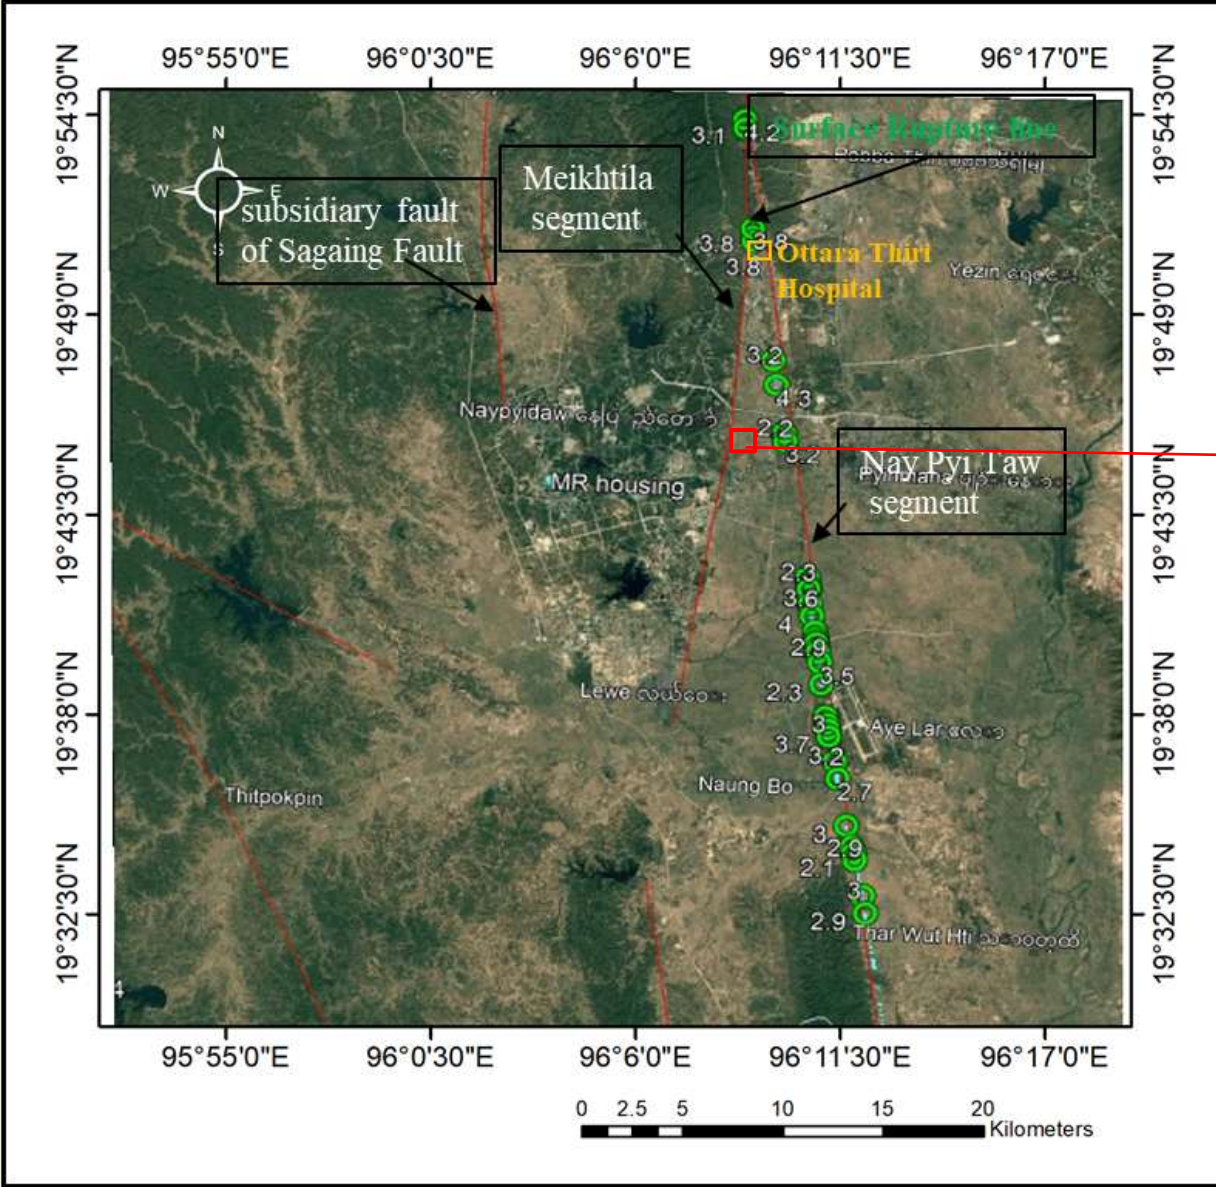
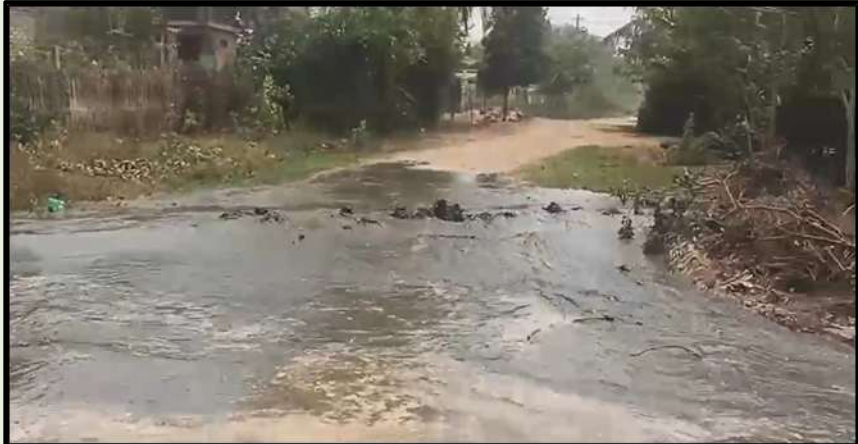
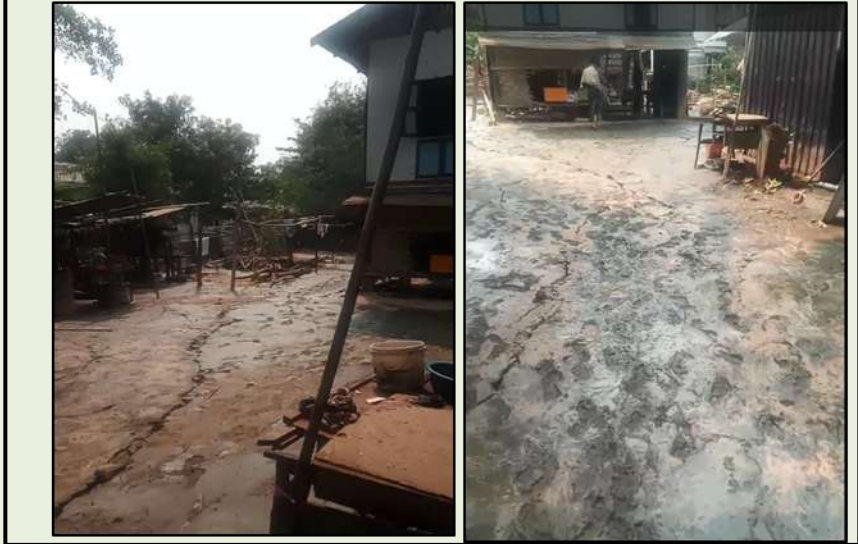
Liquefaction at Nyaungpingyisu village

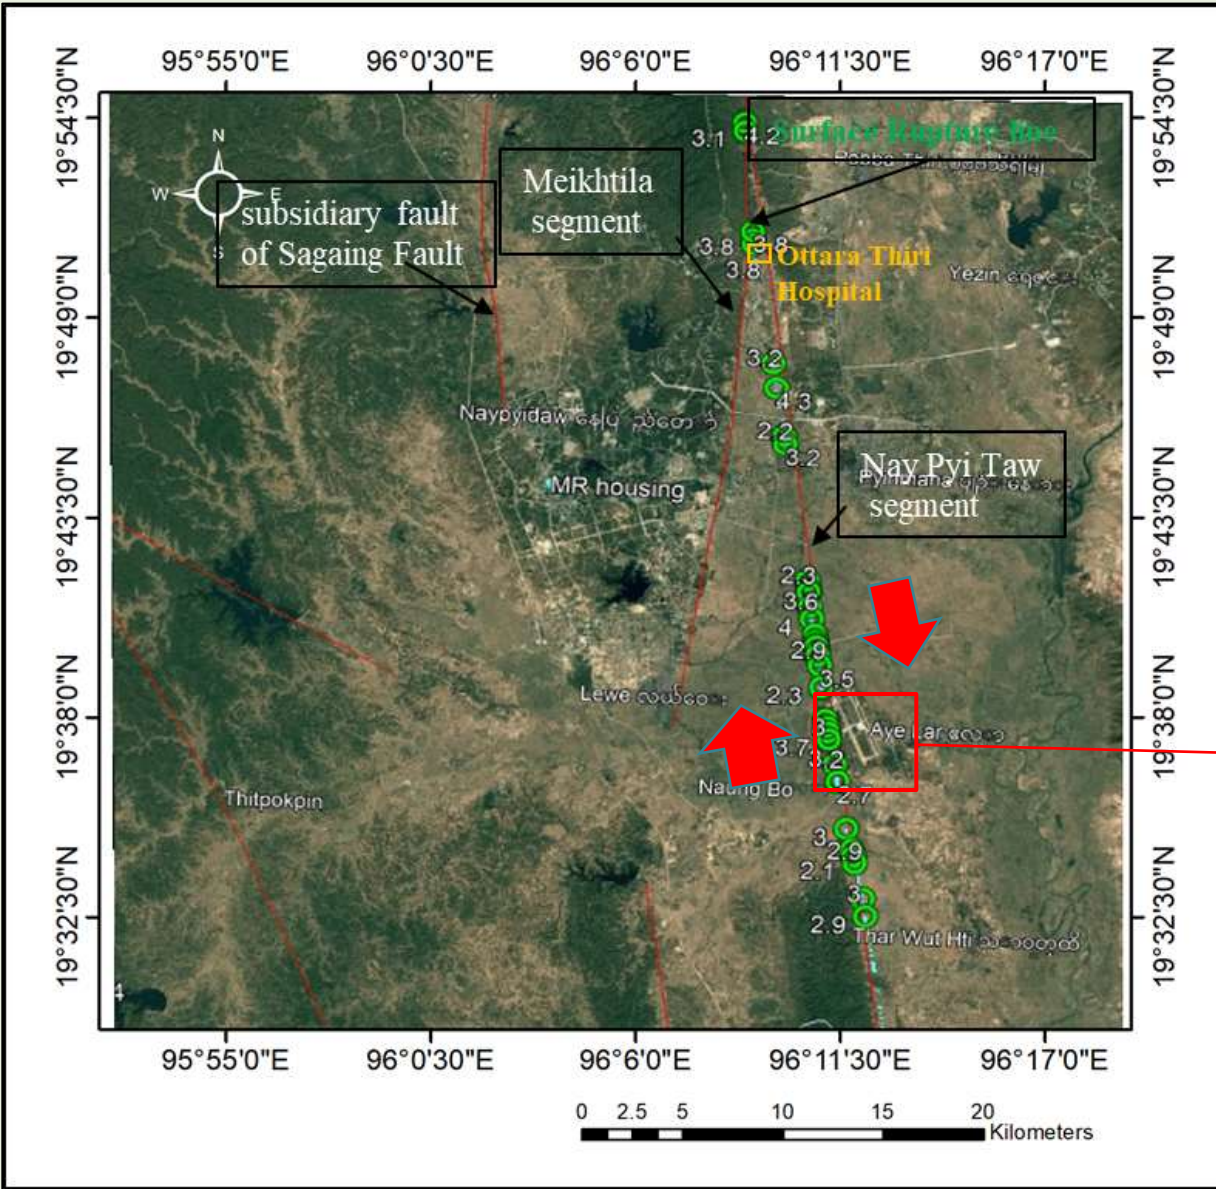
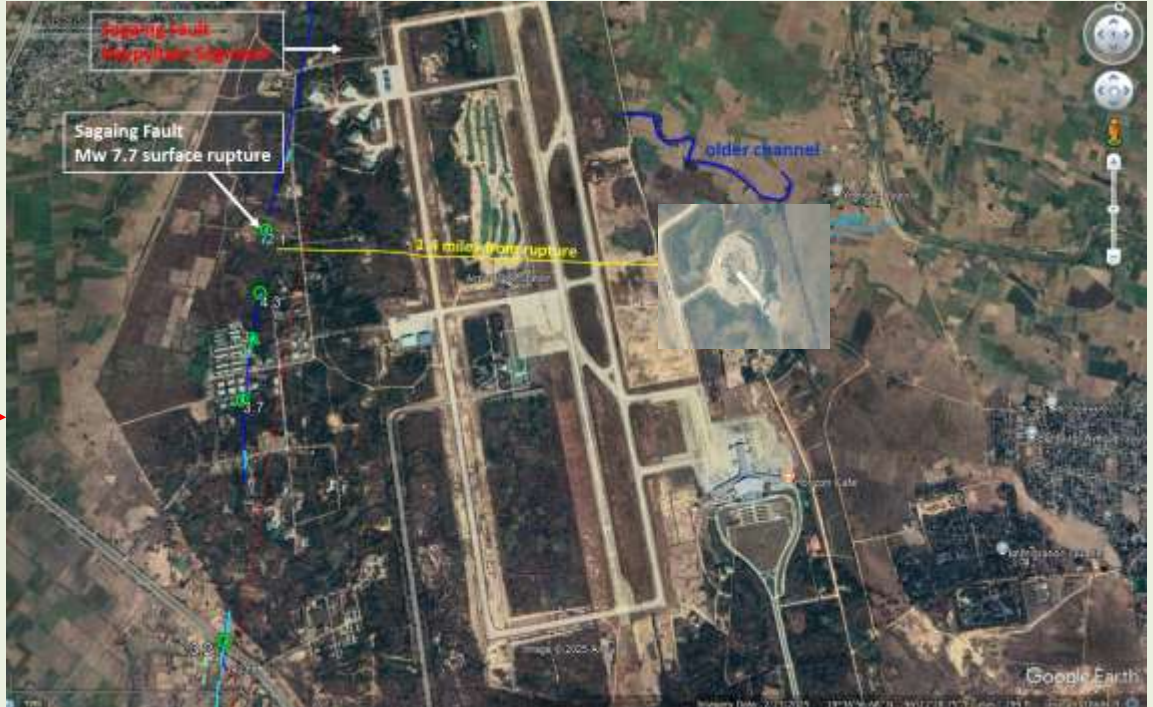
Nay Pyi Taw Air Port, controlling tower
