Site Amplification Characteristics Along Sagaing Fault

By Microtremor Survey

Dy. Head (Geo-Department)
FUKKEN Co., Ltd. (Yangon)
aungsoe@fukkenmyanmar.com
www.fukkenmyanmar.com

Myanmar
Earthquake
Committee

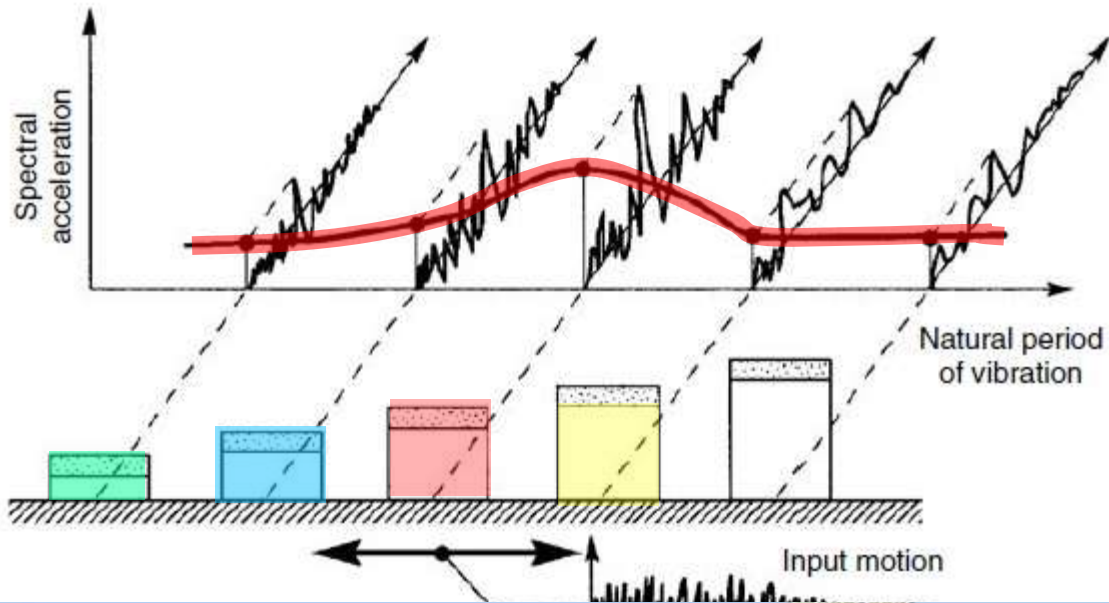
Seismic Waves amplify with local soil deposit. ⇒ **SITE AMPLIFICATION!**

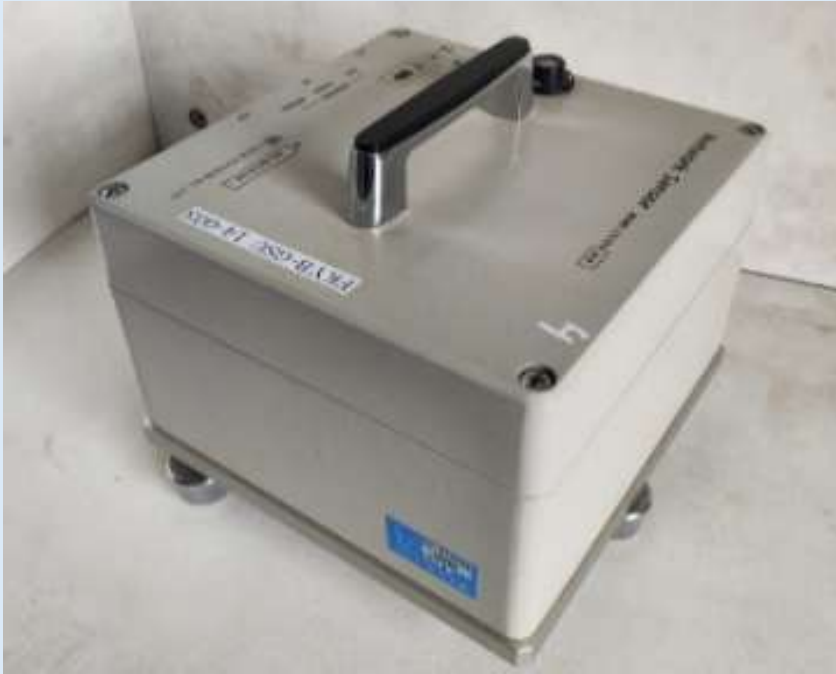
Microtremor Survey Instrument

- Three-component servo accelerometer
- Name: Network Sensor
- Model: CV-374 (AV3) – Tokyo Sokushin
- 24-bit A/D converter
- High resolution for microtremor measurement

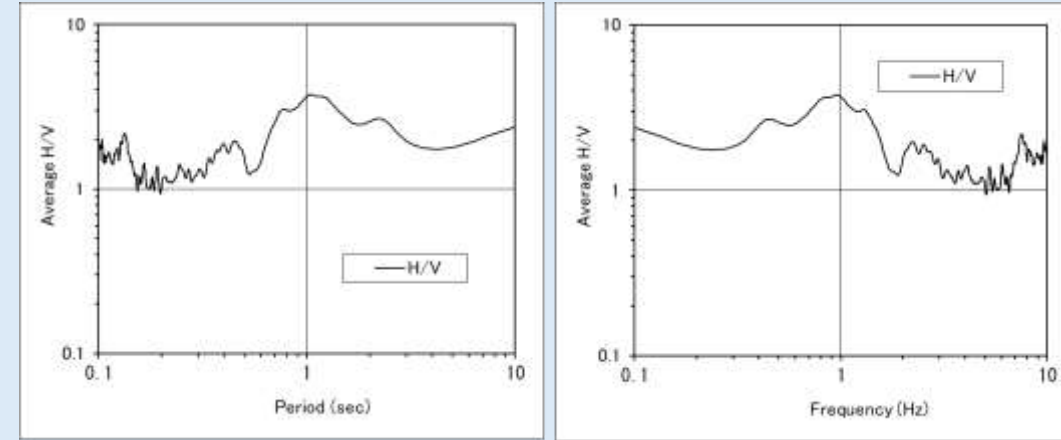
Horizontal to vertical spectrum ratio HVSR

- Record microtremor in EW, NS, and UD directions
- Select stable time windows
- Apply Fourier Transform
- Power Spectrum, smoothed by Parzen Window
- Averaging for HVSR

$$\frac{H}{V}(f) = \frac{\sqrt{P_{EW}(f) + P_{NS}(f)}}{\sqrt{P_{UD}(f)}}$$

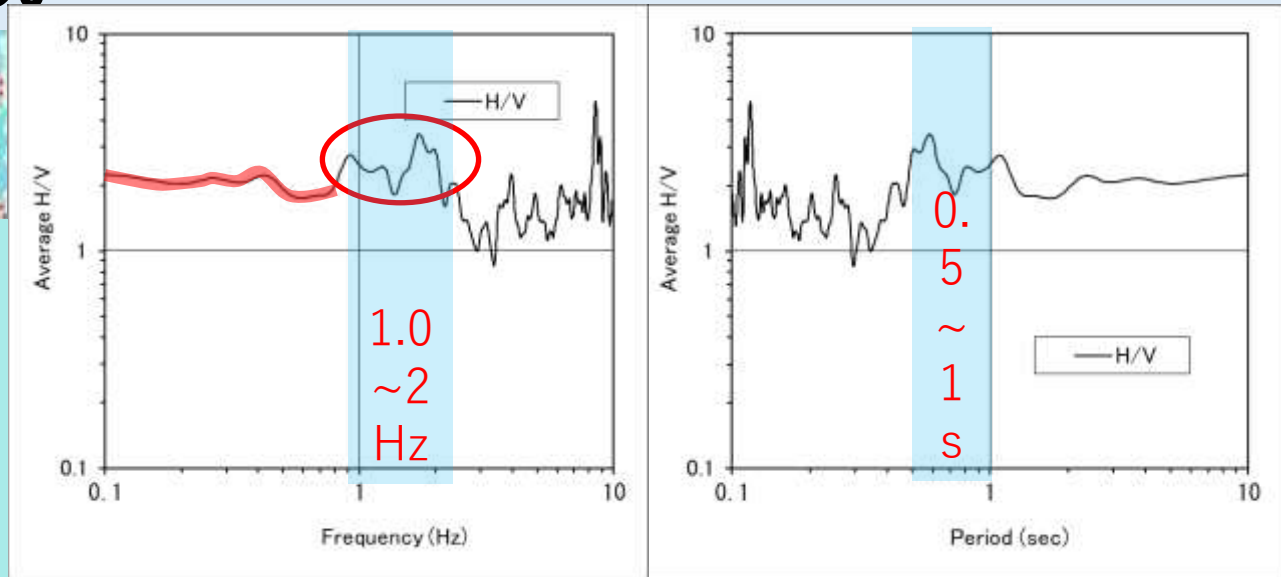
မန္တလေးတိုင်းဒေသကြီး ဝမ်းတွင်း

Amplification > 2.0 for very low Frequency Region.

Old buildings were highly affected!!!

Mandalay - Wundwin (1 Point)

- Dominant frequency range: $1 \sim 2 \text{ Hz}$
- Natural ground period: $0.5 \sim 1 \text{ seconds}$
- Potential amplification: $\sim 2 + \text{times}$
- **Insignificant** Potential amplification for **Low to Medium Height Buildings.**

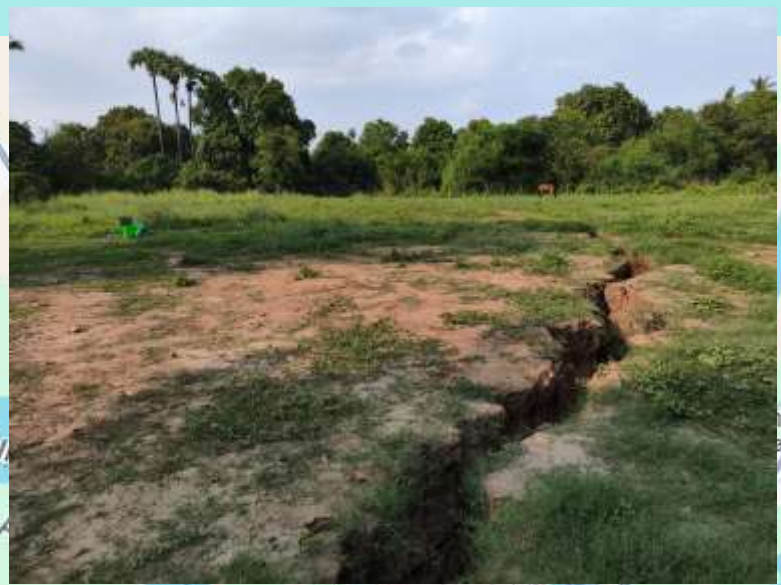
မန္တလေးတိုင်းဒေသကြီး အင်းဝ

Amplification ~ 5

Fault line across the town.

Mandalay - Innwa (1 Point)

- Dominant frequency range: $\sim 1.6 \text{ Hz}$
- Natural ground period: $\sim 0.6 \text{ seconds}$
- Potential amplification: $\sim 5 \text{ times}$
- High Potential amplification for **Small Buildings.**

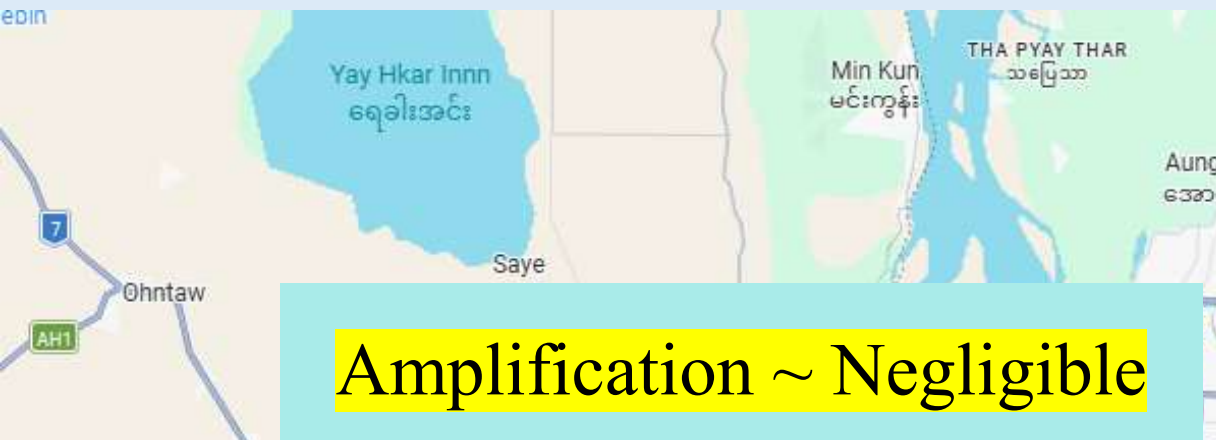
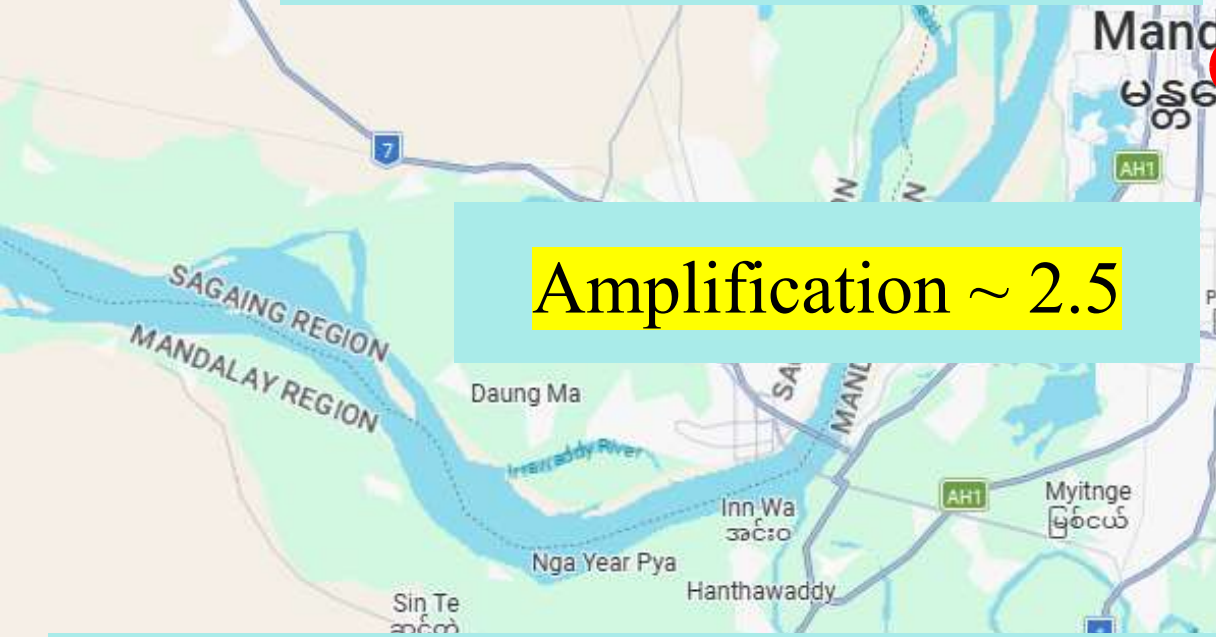
မန္တလေးတိုင်းဒေသကြီး မန္တလေး

Amplification can be larger in west/south of Mandalay

Mandalay – Mandalay City (2 Points)

- Dominant frequency range: $0.5 \sim 2.0 \text{ Hz}$
- Natural ground period: $0.5 \sim 2.0 \text{ seconds}$
- Potential amplification: $\sim 2.5 \text{ times}$
- High Potential amplification for **Medium Height Buildings.**

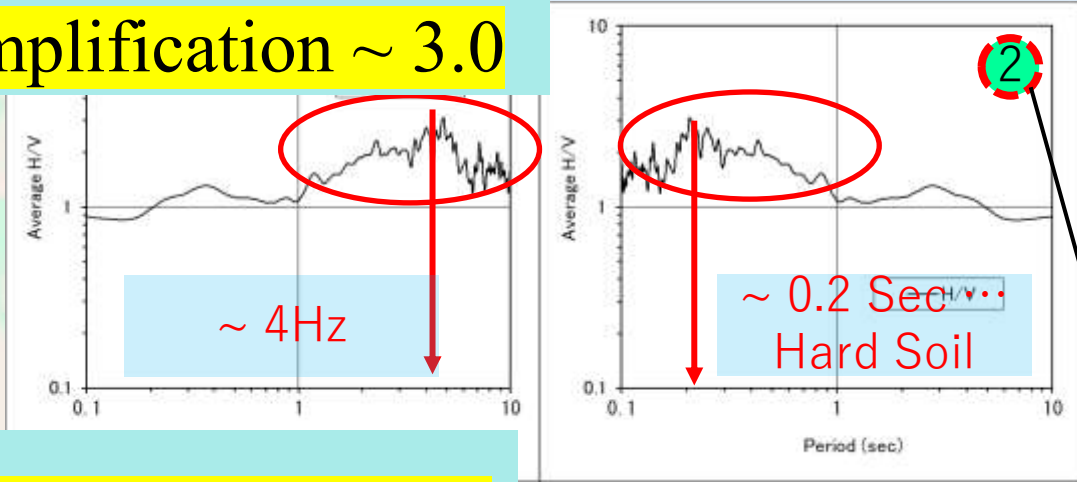
စစ်ကိုင်းတိုင်းဒေသကြီး

Amplification ~ 3.0

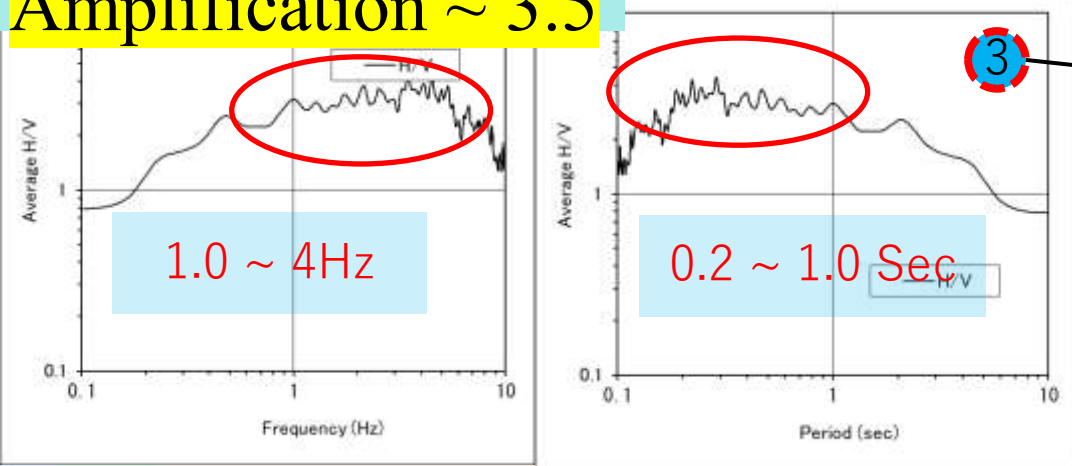
Amplification ~ 3.5

Potentially higher amplification in Southern Part

Sagaing (5 Points)

- **High amplification in South** of Sagaing City (esp. **Low buildings**)

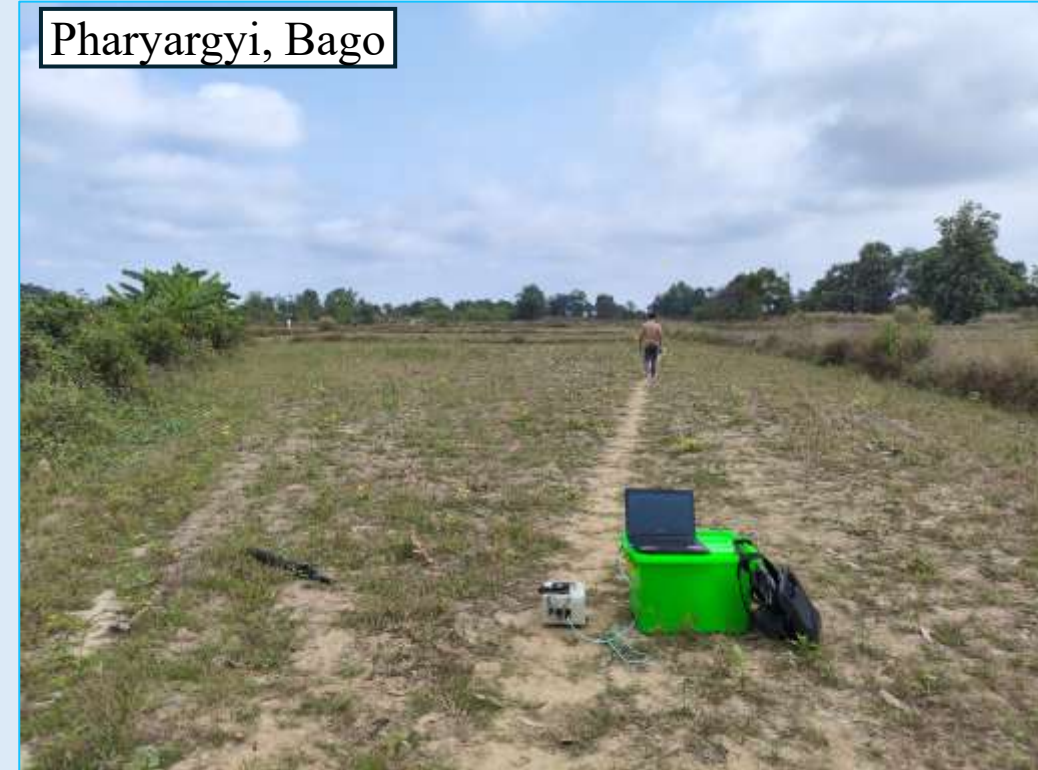
Bago (1 Point @ Phayargyi)

- Dominant frequency range: *0.4~1.0 Hz*
- Natural ground period: *1~2.5 seconds*
- Potential amplification: *3 ~ 3.5 times*
- Potential amplification for **Medium Height Buildings.**
