The Republic of the Union of Myanmar
Ministry of Transport and Communications

Directorate of Water Resources and Improvement of River Systems

“Water Resources in Myanmar after earthquake”

Mr. Aung Myo Khaing (M. Engg; WEM)
Director, DWIR

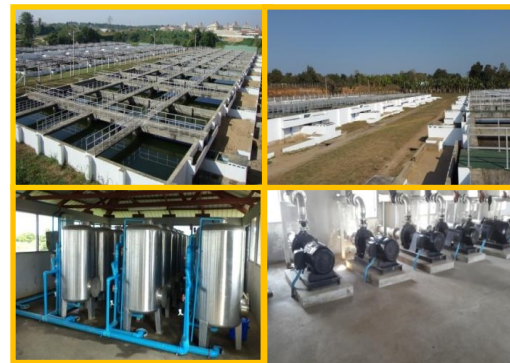
Treatment Plants

Basic Data of NPT waterworks

Population Served	50% of Urban Population
Number of service connections	17123
Total capacity of treatment facilities	27.55 MGD
Disinfection facility	6 Nos

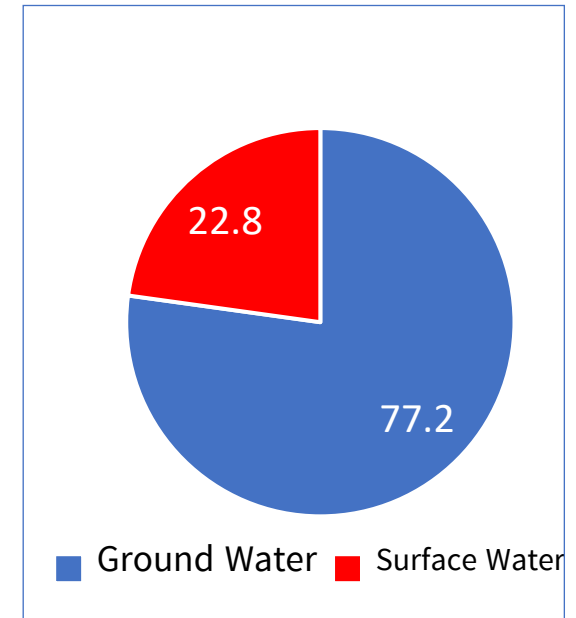
Daily water supply 42 million gallons

| (a) Ground Water | 32.424 mill (77.2%) |
| (b) Surface Water | 9.576 mill (22.8 %) |

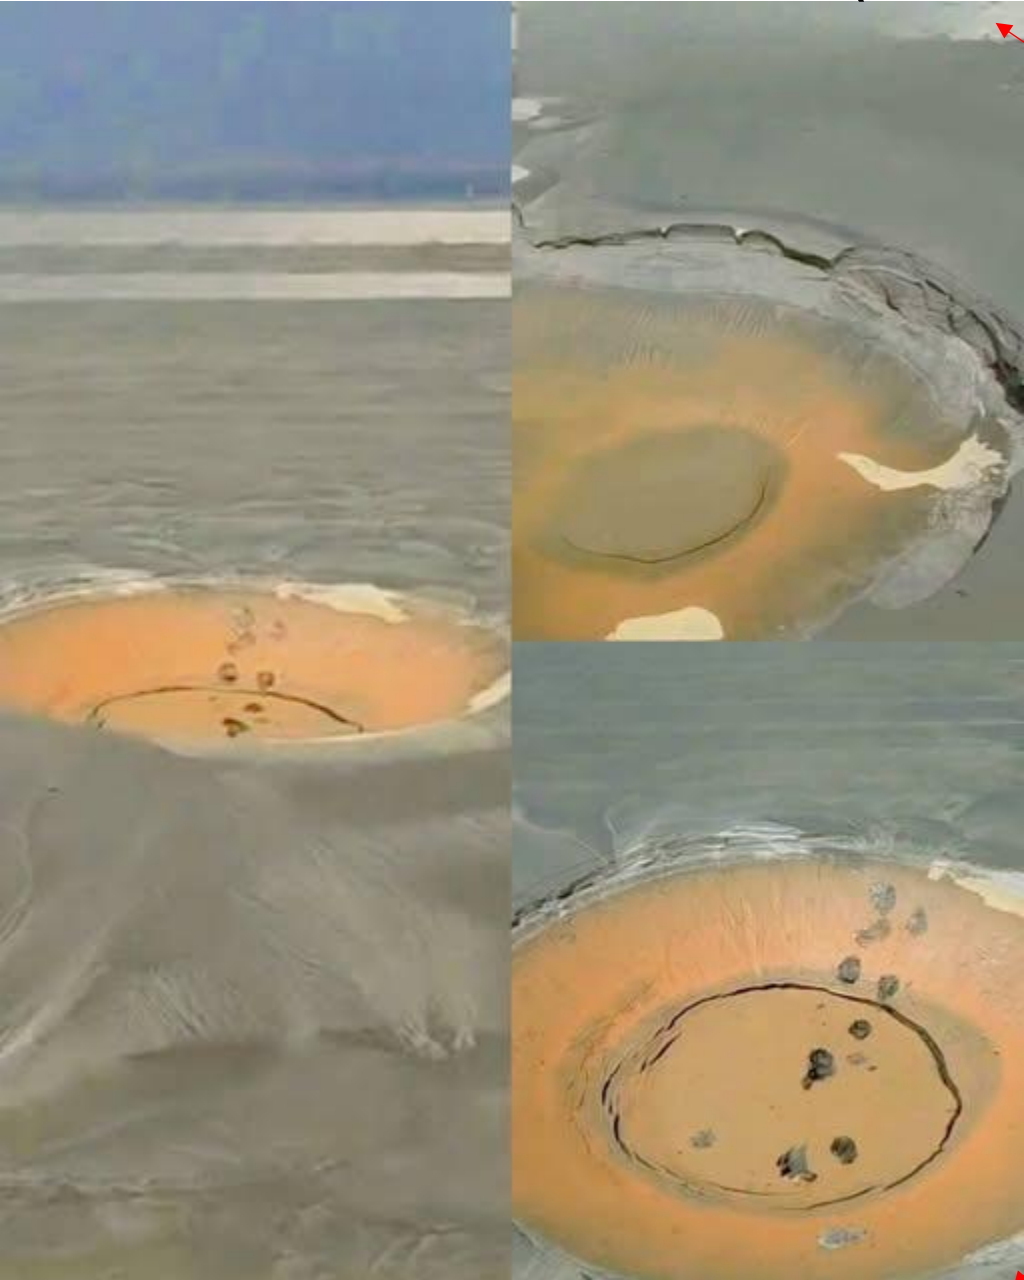
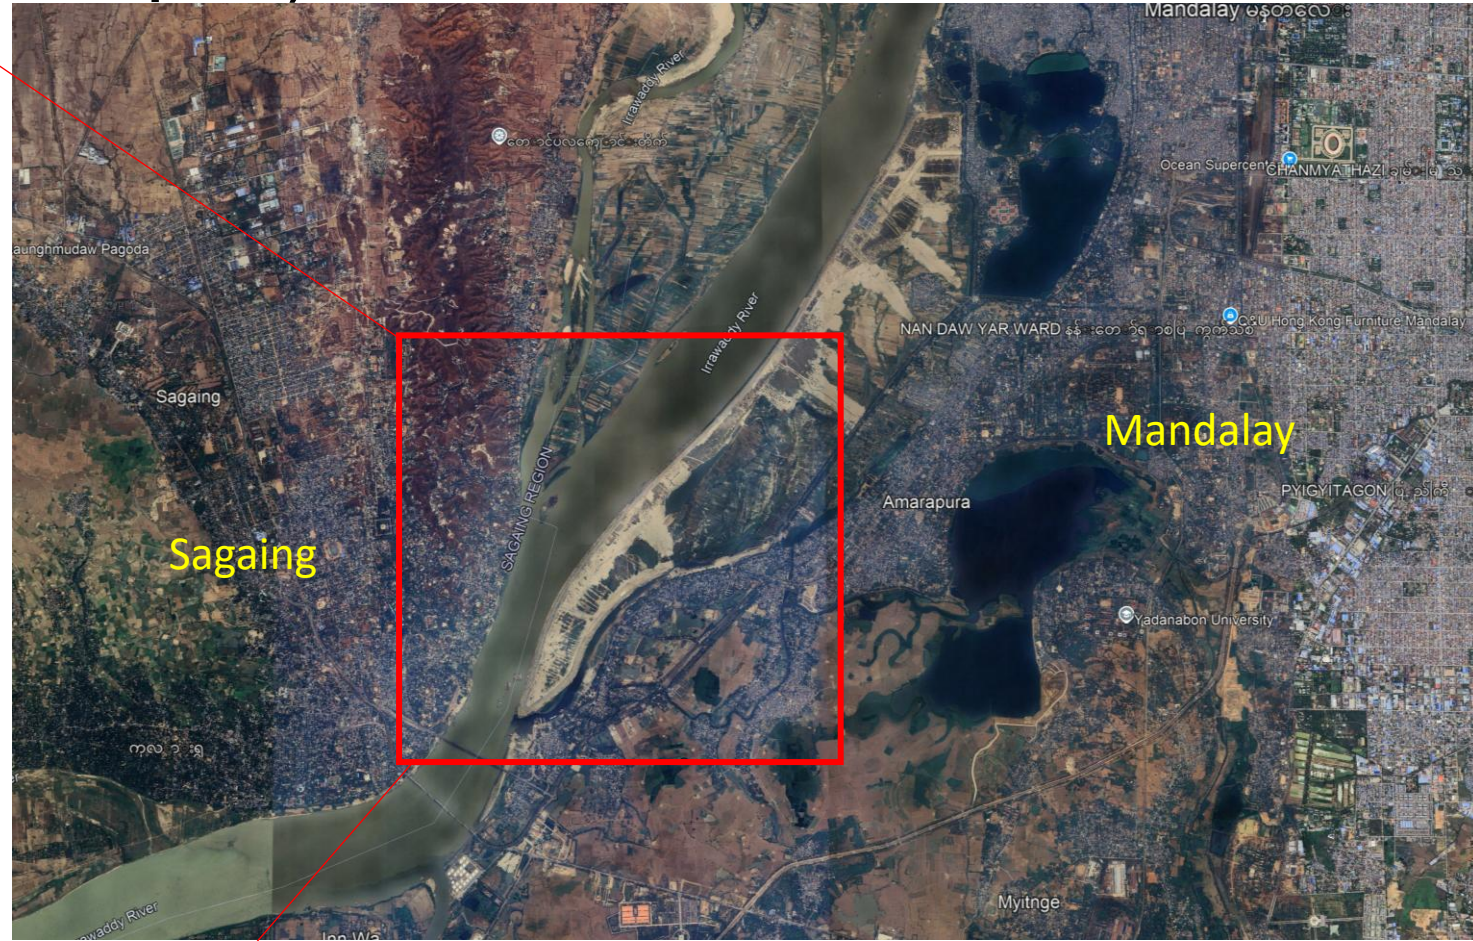
Some of Sink holes in the Ayeyarwady river (near Mandalay) after the earthquake.

But those sink holes disappeared later

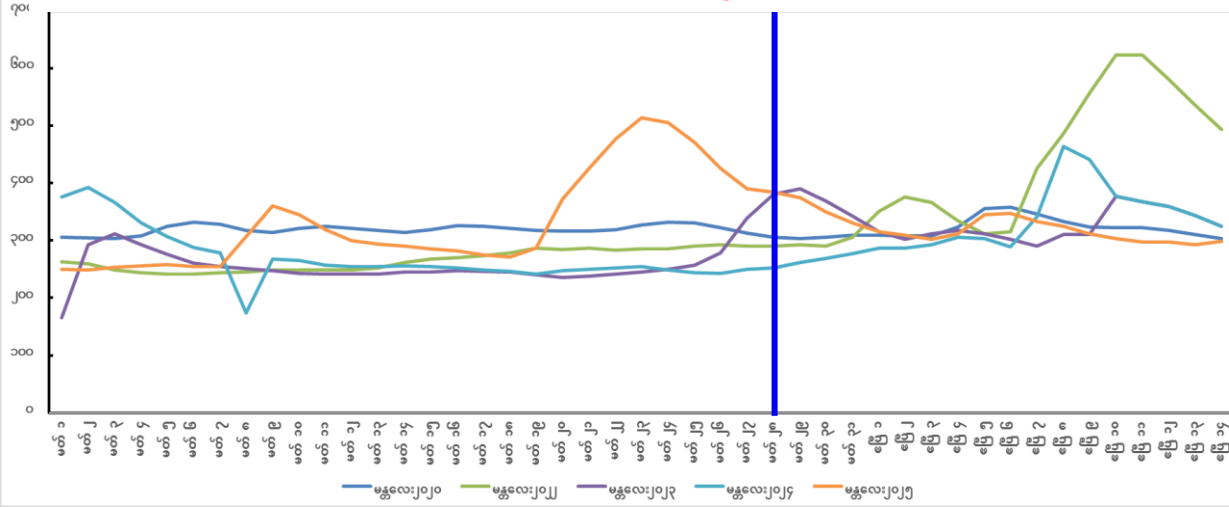
Comparison of Water Level of **Mandalay** (Ayeyarwady river) 2020-2025

1. Water level of Ayeyarwady river at Mandalay station didn't low down after earthquake
2. Water level of Ayeyarwady river increased in NyaungOo & Magway was increased immediate after earthquake
3. Sittaung river water level didn't show significant low down
4. Continuous monitoring is required
